INSTALLATION RESTORATION PROGRAM

151 AREFG, Utah Air National Guard Sait Lake City International Airport Sait Lake City, Utah.

299 CF, Utah Air National Guard Francis Peak Radar Station, Francis Peak, Utah.

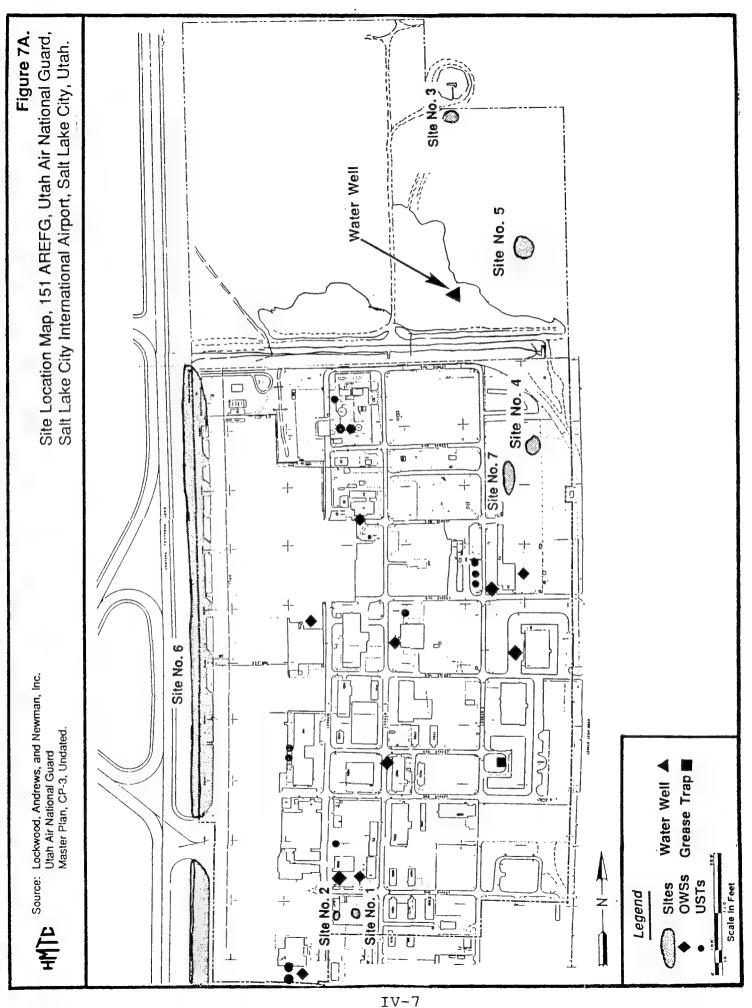
Interviews with Base personnel and subsequent site inspections resulted in the identification of seven sites potentially contaminated with HM/HW. Figure 7A illustrates the locations of the identified sites at the Base.

The area south of 2nd Street between E and F Streets was reportedly used as a pesticide dump site (Figure 7A). No information exists on the amounts, contents, or time of operation. During the site visit, no stressed vegetation was observed; however, the area had recently been graded flat.
